Washington State
School Seismic Safety Assessments Project

MORTON ELEMENTARY SCHOOL MAIN BUILDING Morton School District

SEISMIC UPGRADES CONCEPT DESIGN REPORT

June 2021

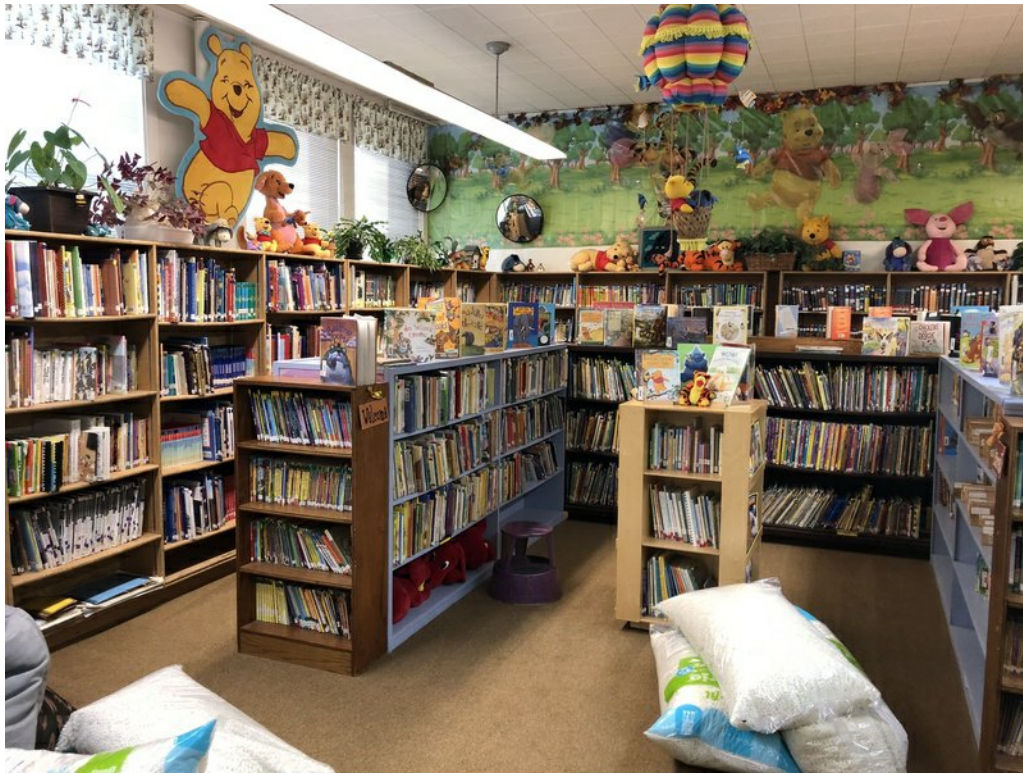
Figure 1-3. Library Bookshelves Should Be Braced

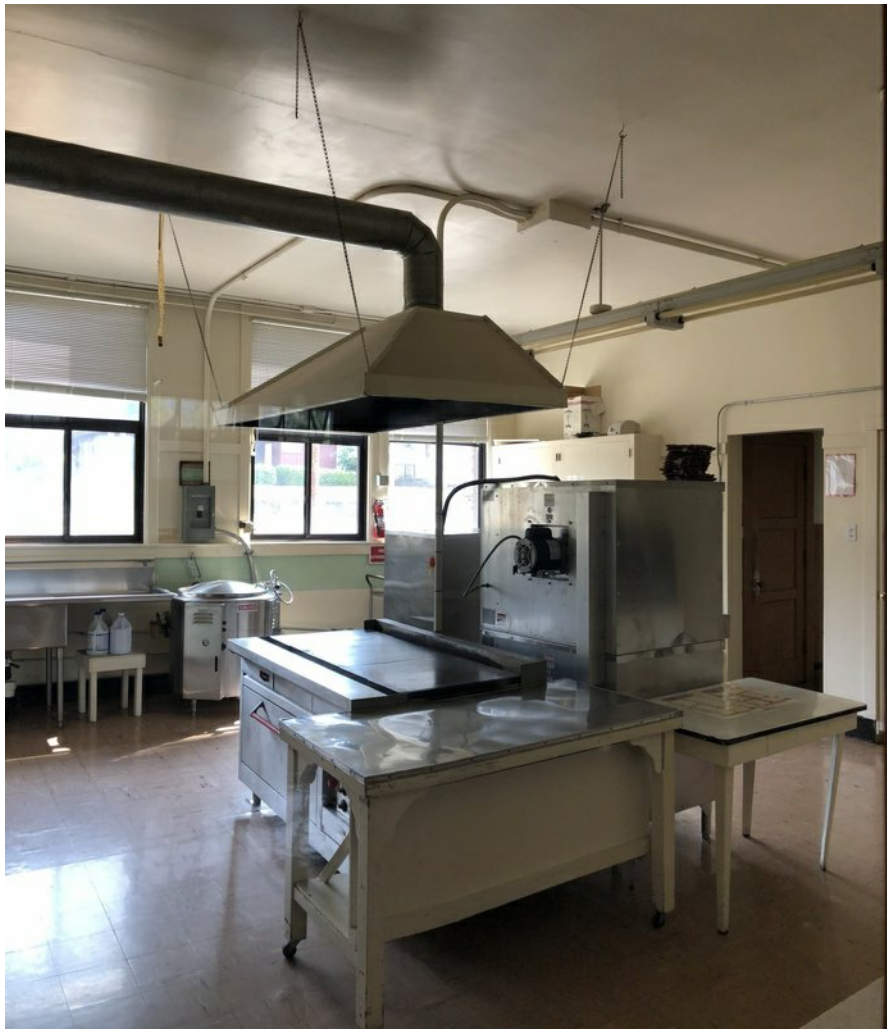
Figure 1-4. Kitchen - Tall Nonstructural Components Unbraced

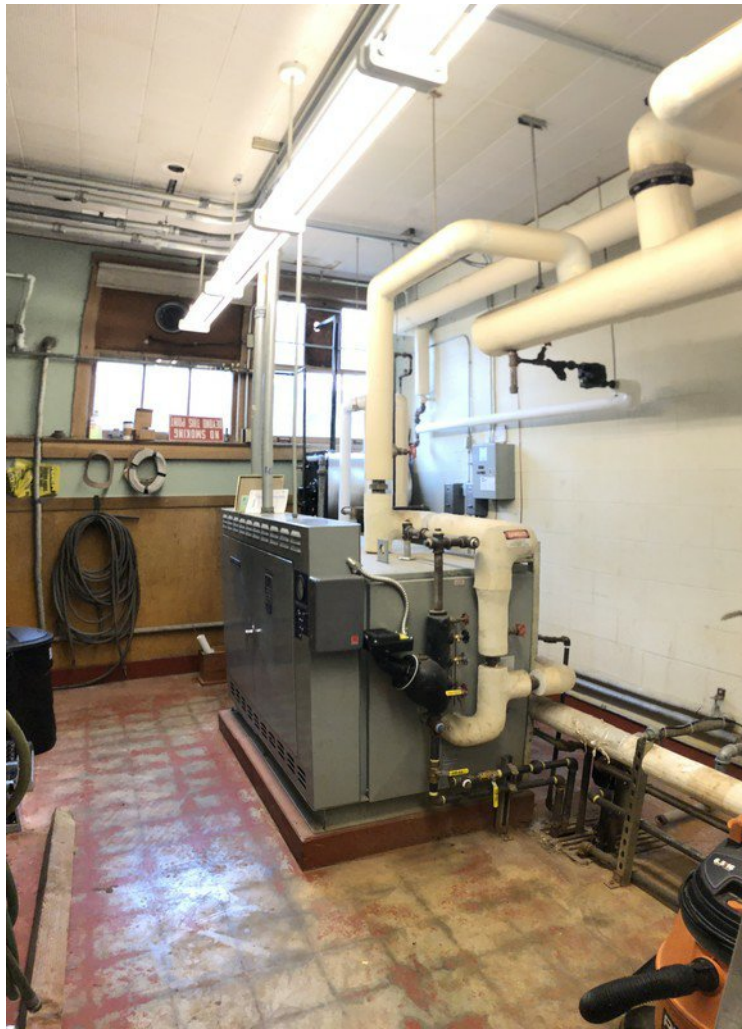
Figure 1-5. Mechanical Room with Unbraced Equipment

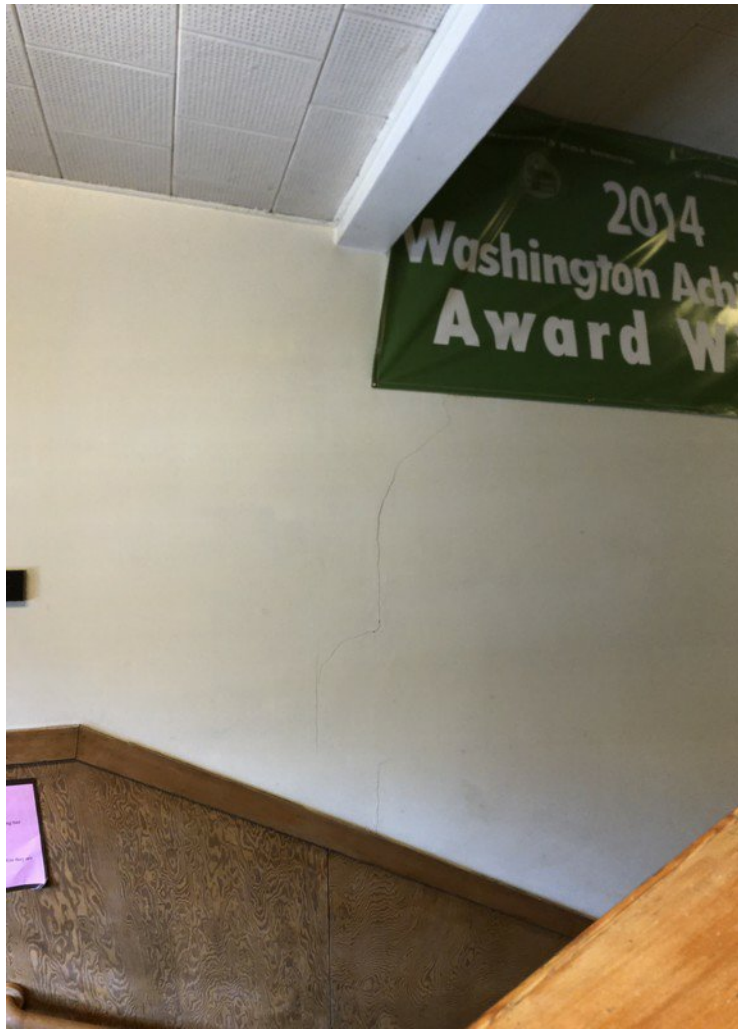
Structural System	Description
Structural Roof	No visible signs of corrosion, damage, or deterioration.
Structural Floor	No visible signs of corrosion, damage, or deterioration.
Foundations	Unknown.
Gravity System	Cracking observed on interior wall at stairwell.
Lateral System	No visible signs of corrosion, damage, or deterioration.

Figure 1-6. Cracking at Interior Finishes

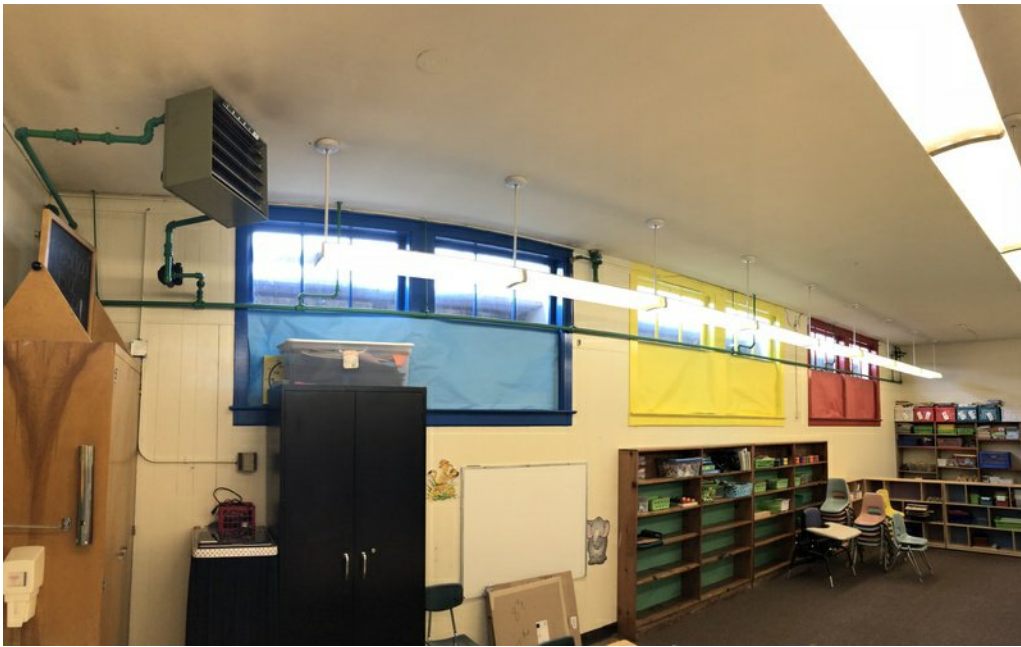
Figure 1-9. Typical Classroom with Unbraced Nonstructural Components

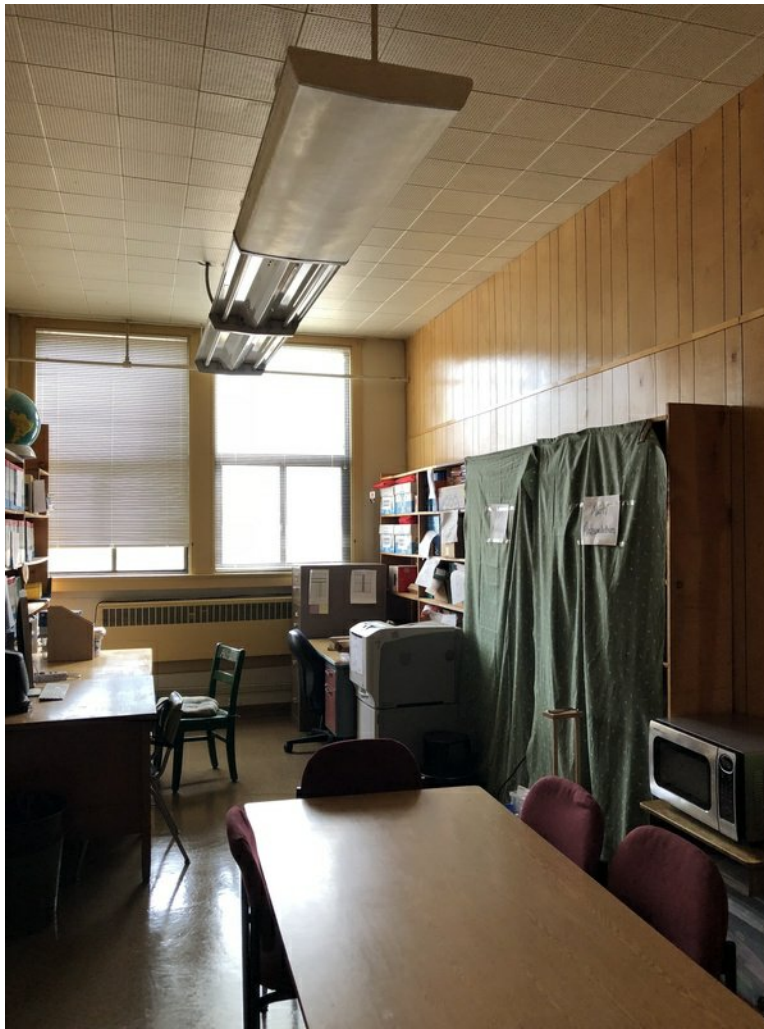
Figure 1-10. Unknown Ceiling Finish Bracing, Typical
